Company Name: Amber Court Management (No.1) Limited

Inspector Name: Thomas Dellow MTPI AssocRICS

Inspection Date: 18 February 2025

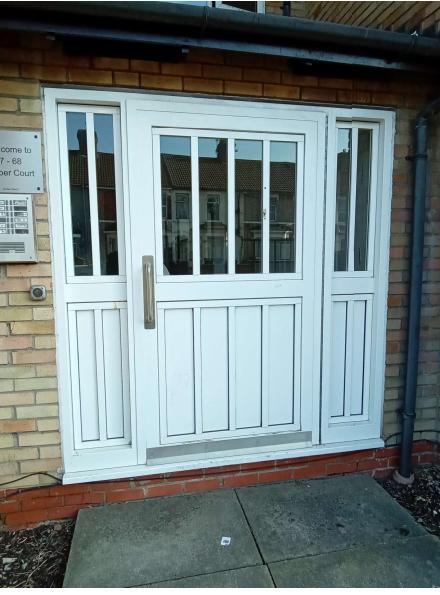
Internal Inspection	Acceptable	Not Acceptable	N/A	Comments	Action
Entrances (Main doors)	✓			The entrances were secure at time of inspection.	None
Hallway (Communal Lobbies and Stairs)	✓			The hallways were accessible. Carpeting has been installed to the first and second floors and improve the visual appeal of the block.	None
Lighting (Standard and Emergency Lighting)	✓			Emergency lighting was tested as part of this inspection and found to be satisfactory.	None
Internal Doors (Compartment Doors)		✓		1st floor lobby door catching on carpet. Contractor instructed to adjust	Review
Cupboard Doors (Electrical Cupboard Doors)	✓			Cupboard doors were secure at time of inspection.	None
Windows (Communal Windows)	✓			The communal windows appeared in good visual condition.	None
Signage (Communal Notices)	✓			Signage is up to date and available.	None
Additional Comments					None

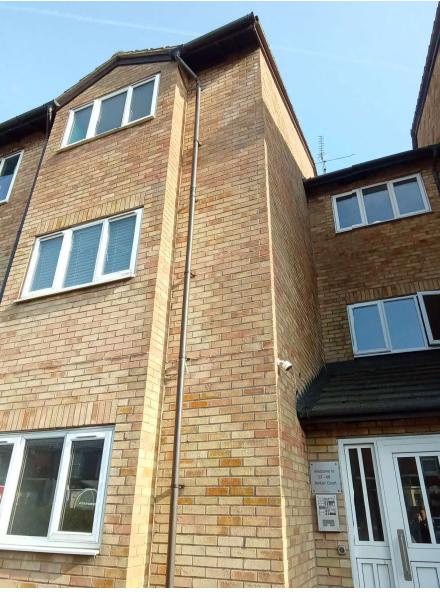
External Inspection	Acceptable	Not Acceptable	N/A	Comments	Action
Exterior Structure (The Building)	✓			The exterior appeared to be in good visual condition.	None
Guttering (Gutters and Fascia)	✓			The guttering appeared to be in good visual condition. A contractor has recently reviewed the guttering.	None
Roofing (Tiles and Cladding)	✓			The roof was inspected from ground level and appeared to be in good visual condition.	None
Communal Grounds (Gardens and Common Areas)	✓			The communal grounds are accessible. Foliage and grass are well maintained.	None
Bin Store (Waste Disposal Areas)	✓			The bin store is tidy.	None
Car Park (Vehicle Parking)	✓			The car park was accessible.	None
Bike Store (Bicycle Areas)			✓	There is no communal bike store.	None
Additional Comments					None
