**Type 2  
Asbestos Survey of:**

**Site Identification:** ASS03247/4

**Issue Date:** 13<sup>th</sup> April 2007

Communal Areas  
Block 1 Flats 57-68  
Amber Court  
Colbourne Street  
Swindon

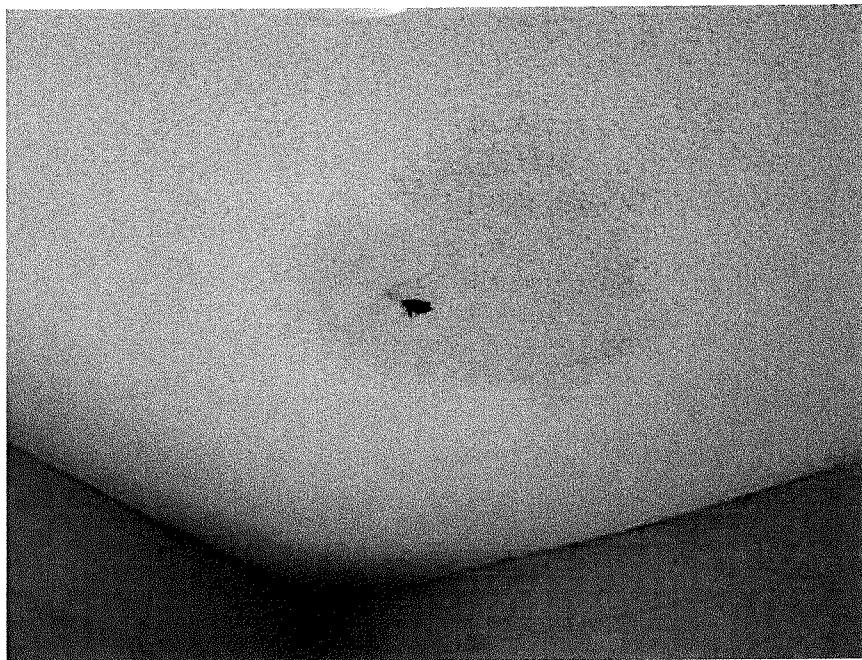
Photo Ref No. 5386

Sample number: 001/06  
Reason for no sample:  
Position: Ceiling  
Material use: Textured coating  
Condition:  
Product type:  
Surface treatment:  
Amount:

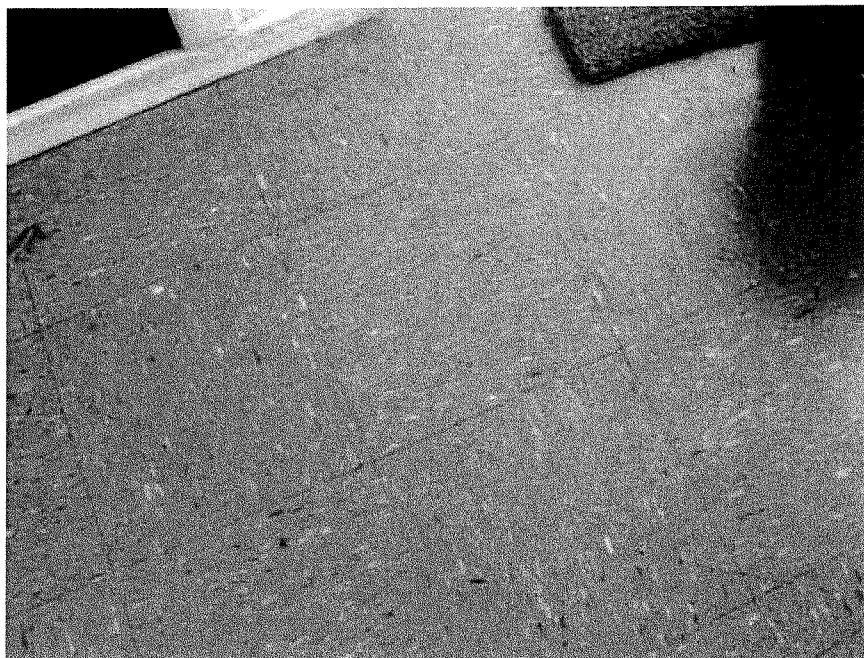
Photo Ref No. 5379

Sample number: 002/02  
Reason for no sample:  
Position: Floor  
Material use: Floor tiles  
Condition:  
Product type:  
Surface treatment:  
Amount:

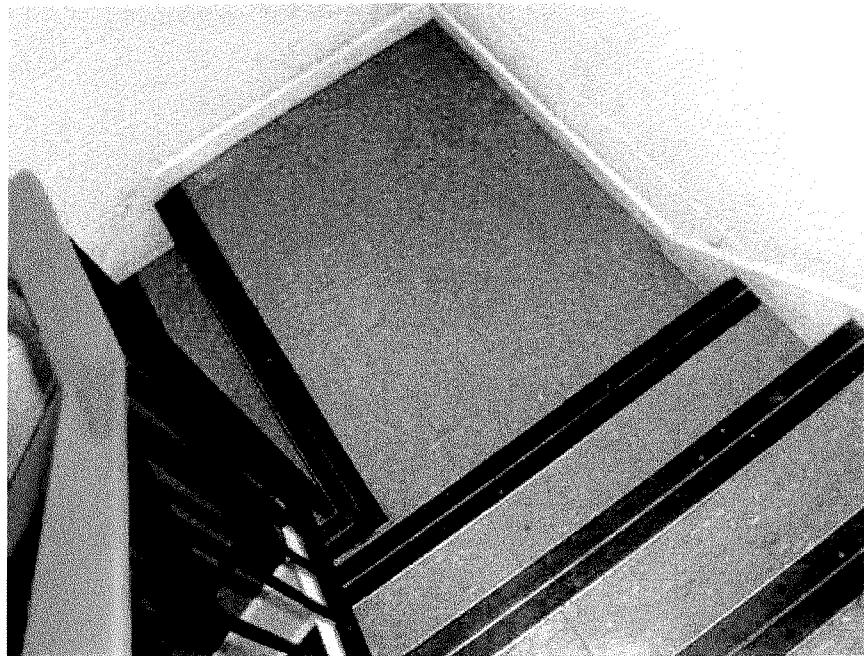
Photo Ref No. 5377

Sample number: 002/01  
Reason for no sample:  
Position: Floor  
Material use: Floor tiles  
Condition:  
Product type:  
Surface treatment:  
Amount:
